September 18, 2020

Deer Run Home Owners  
Poulsbo, WA 98370

Thank you for having me evaluate four trees in a Native Growth Protection Area (NGPA) your community manages for risk posed to nearby homes. To assess the trees addressed in this memo I combined my field experience and education with current accepted practices as defined by the American National Standards Institute (ANSI) and the International Society of Arboriculture (ISA).

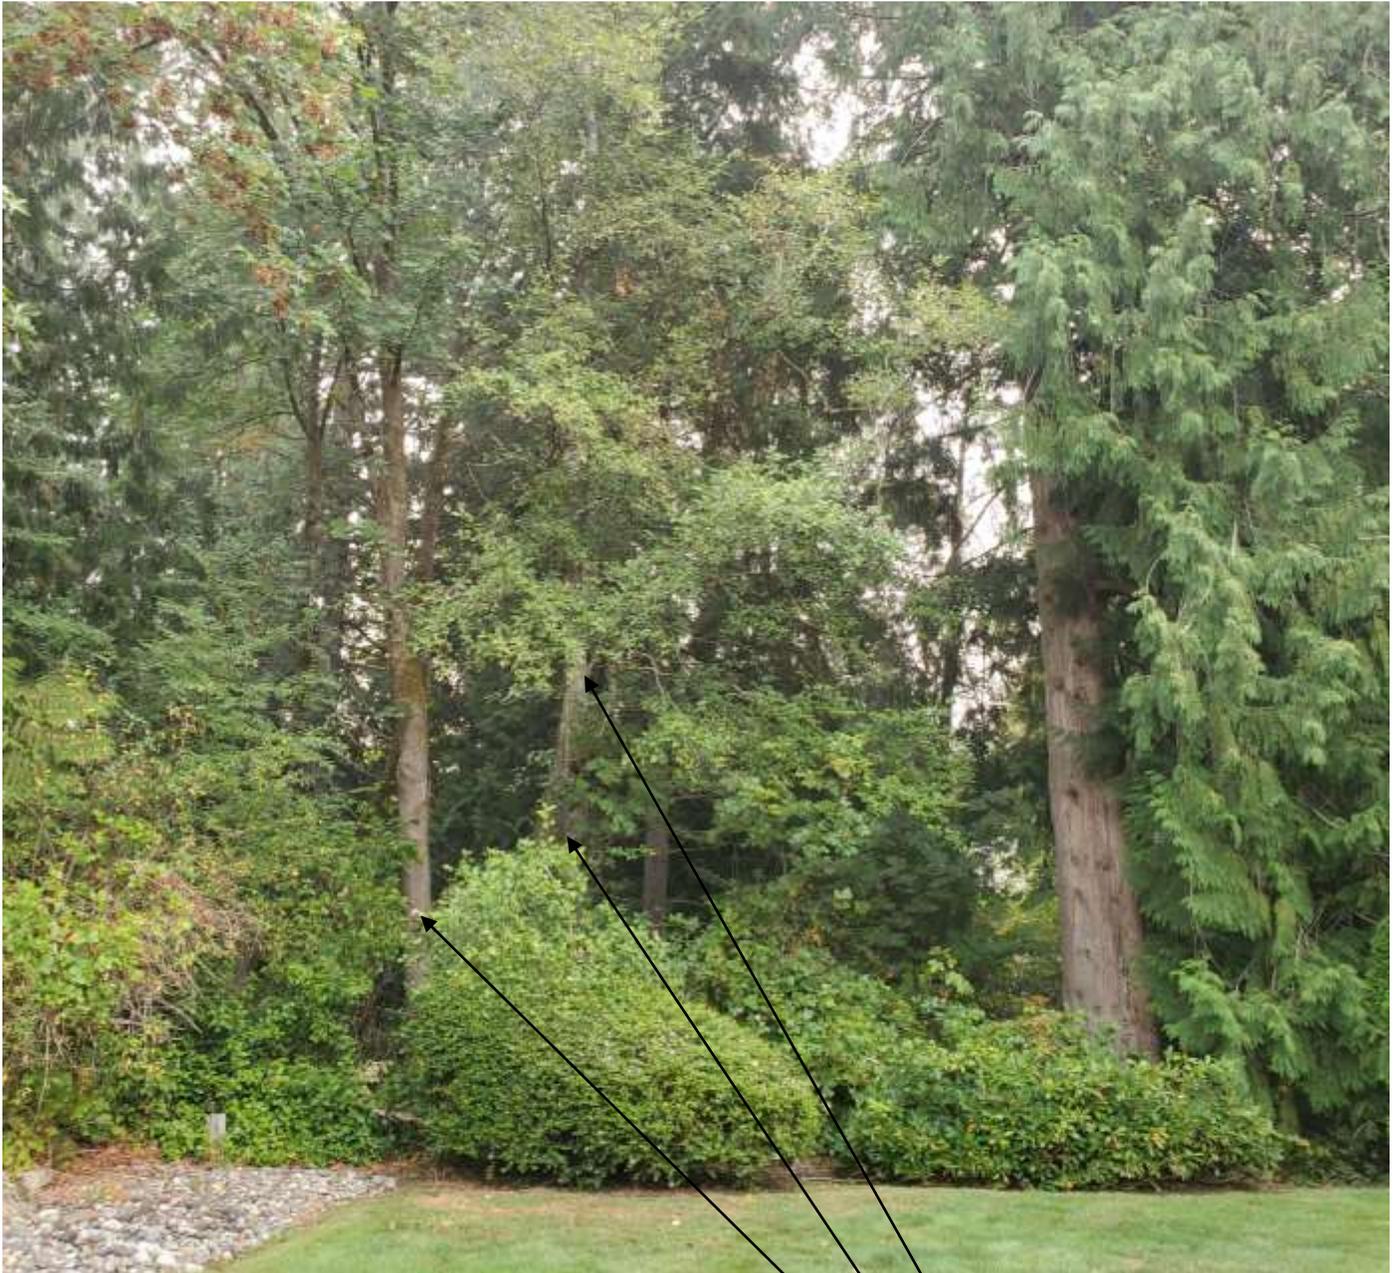
This tree leans to the west towards the back yard. It has a slightly serpentine trunk which could cause it to move in a more unpredictable direction in a wind event. Overall, this tree is in early decline. It poses a low risk of failure but its height is within range of the home.

This tree is in early decline but very stable at its base. It poses a low risk of trunk failure and a moderately low risk of branch failure.

**Photo 1:** Location of Trees 247, 248, 249.

- Choose to monitor this tree or remove to a short stump.
- If the tree is removed, do not remove the stump.

- No work is recommended for this tree at this time.

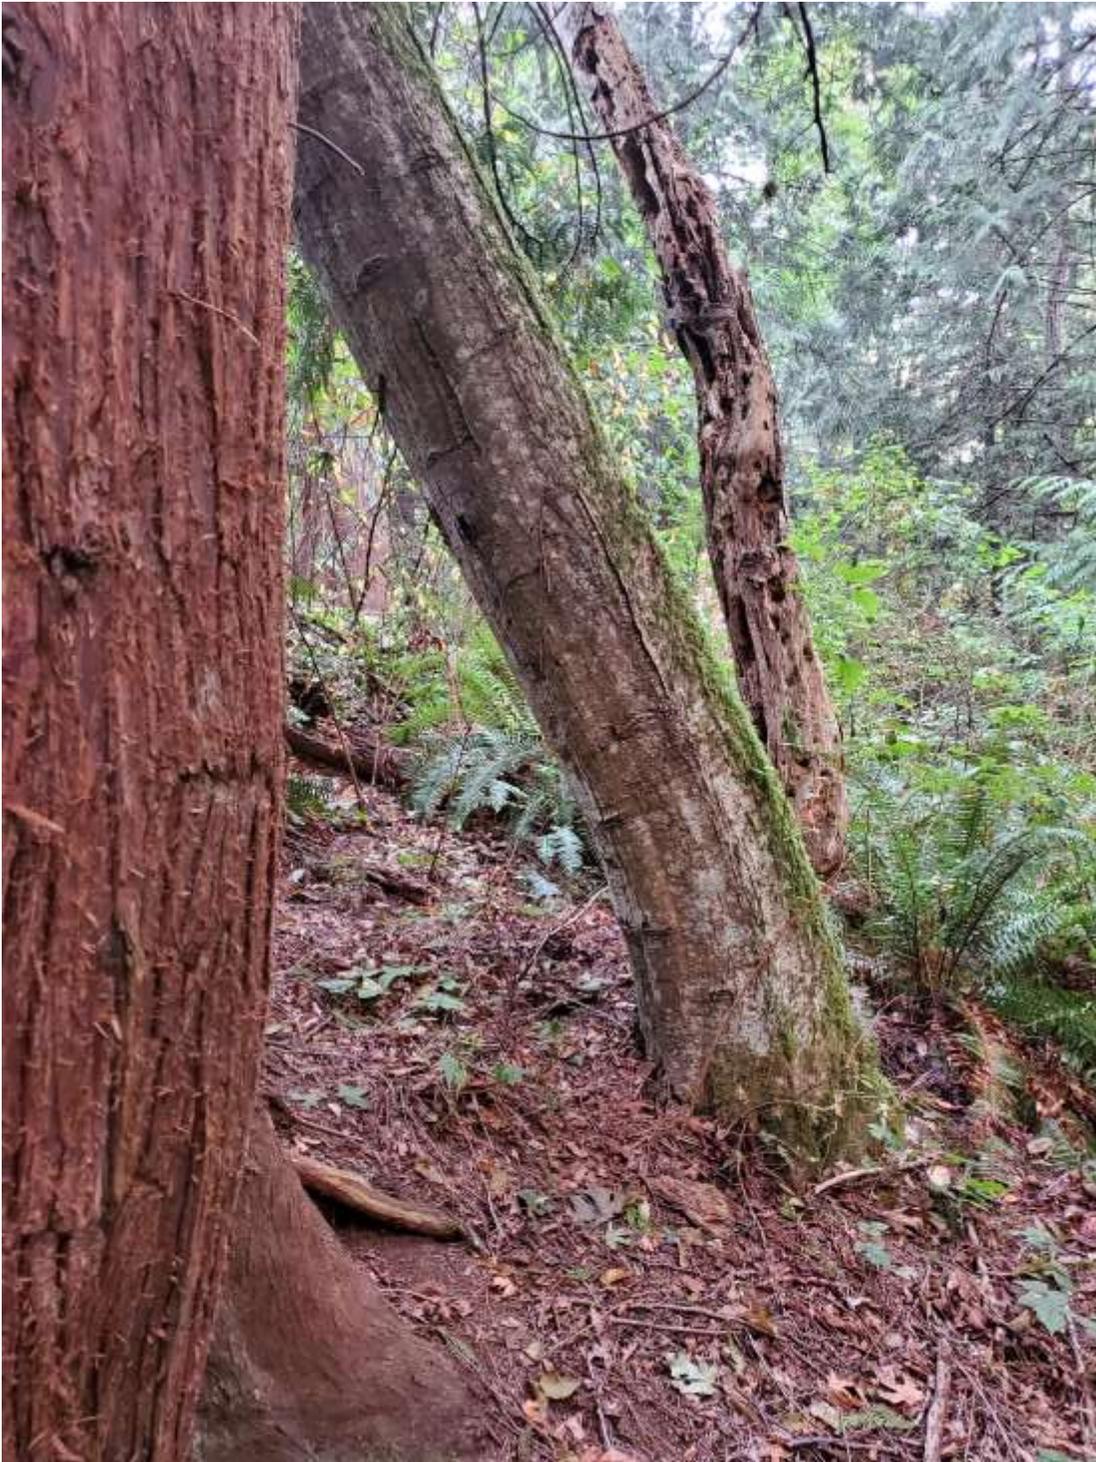
This tree stands downhill from the other two trees in this area. Its lower trunk leans and is bowed significantly to the northwest. It is in average condition and somewhat protected by other trees in the area.

The target in the event of a lower trunk failure is the back yard – this is a moderate possibility. It is possible that this type of failure could cause parts of the tree to reach the home but it is unlikely this tree will increase in health or vigor.

**Photo 2:** Base of Tree 249.

- Choose to monitor this tree or remove to a short stump.
- If the tree is removed, do not remove the stump.

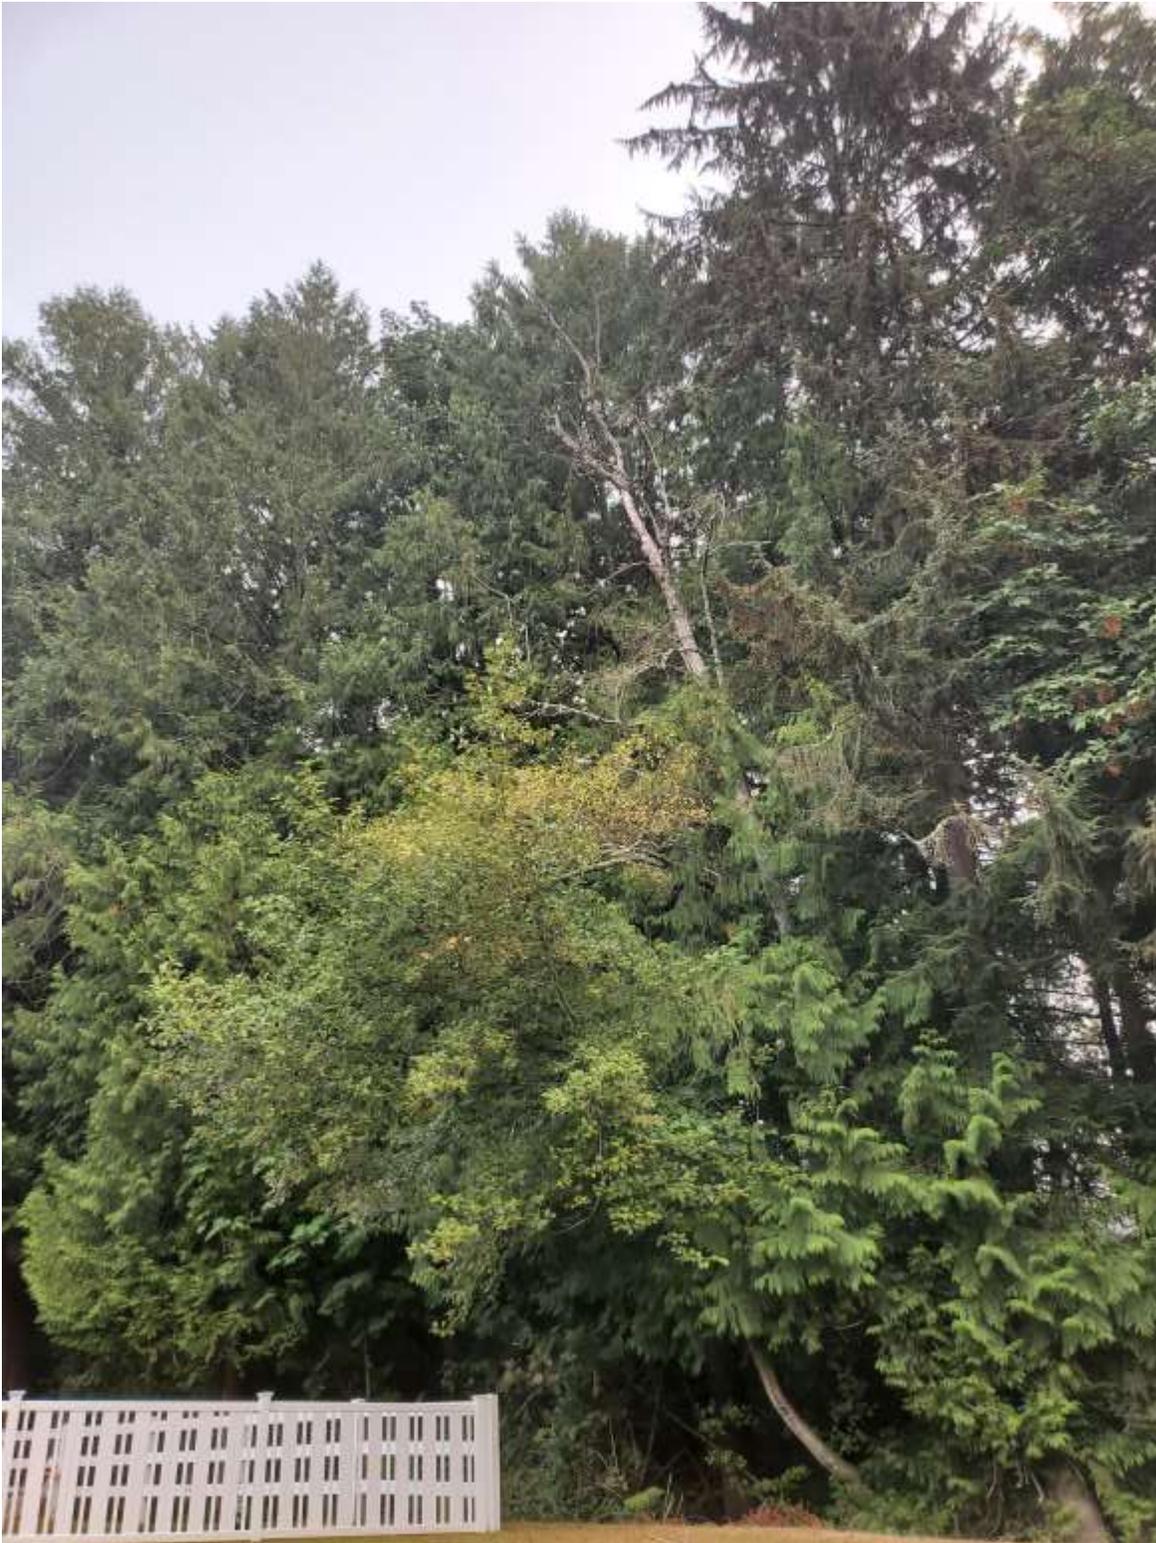
This tree is nearly dead with much of its upper trunk and branches very brittle and unstable (Photo 3). Failure of dead tree parts would likely impact the fence or backyard of the home. There is a high possibility of failure with a significant consequence.

**Photo 3:** Dead top of Tree 250.

- Remove this tree to a short stump and remove the debris from the area.
- Leave the stump intact.
